CIVIL AERONAUTICS BOARD

AIRCRAFT ACCIDENT REPORT

AMERICAN AIRLINES, INC., BOEING 707-123B
N 7506A, JAMAICA BAY, LONG ISLAND, NEW YORK,
MARCH 1, 1962

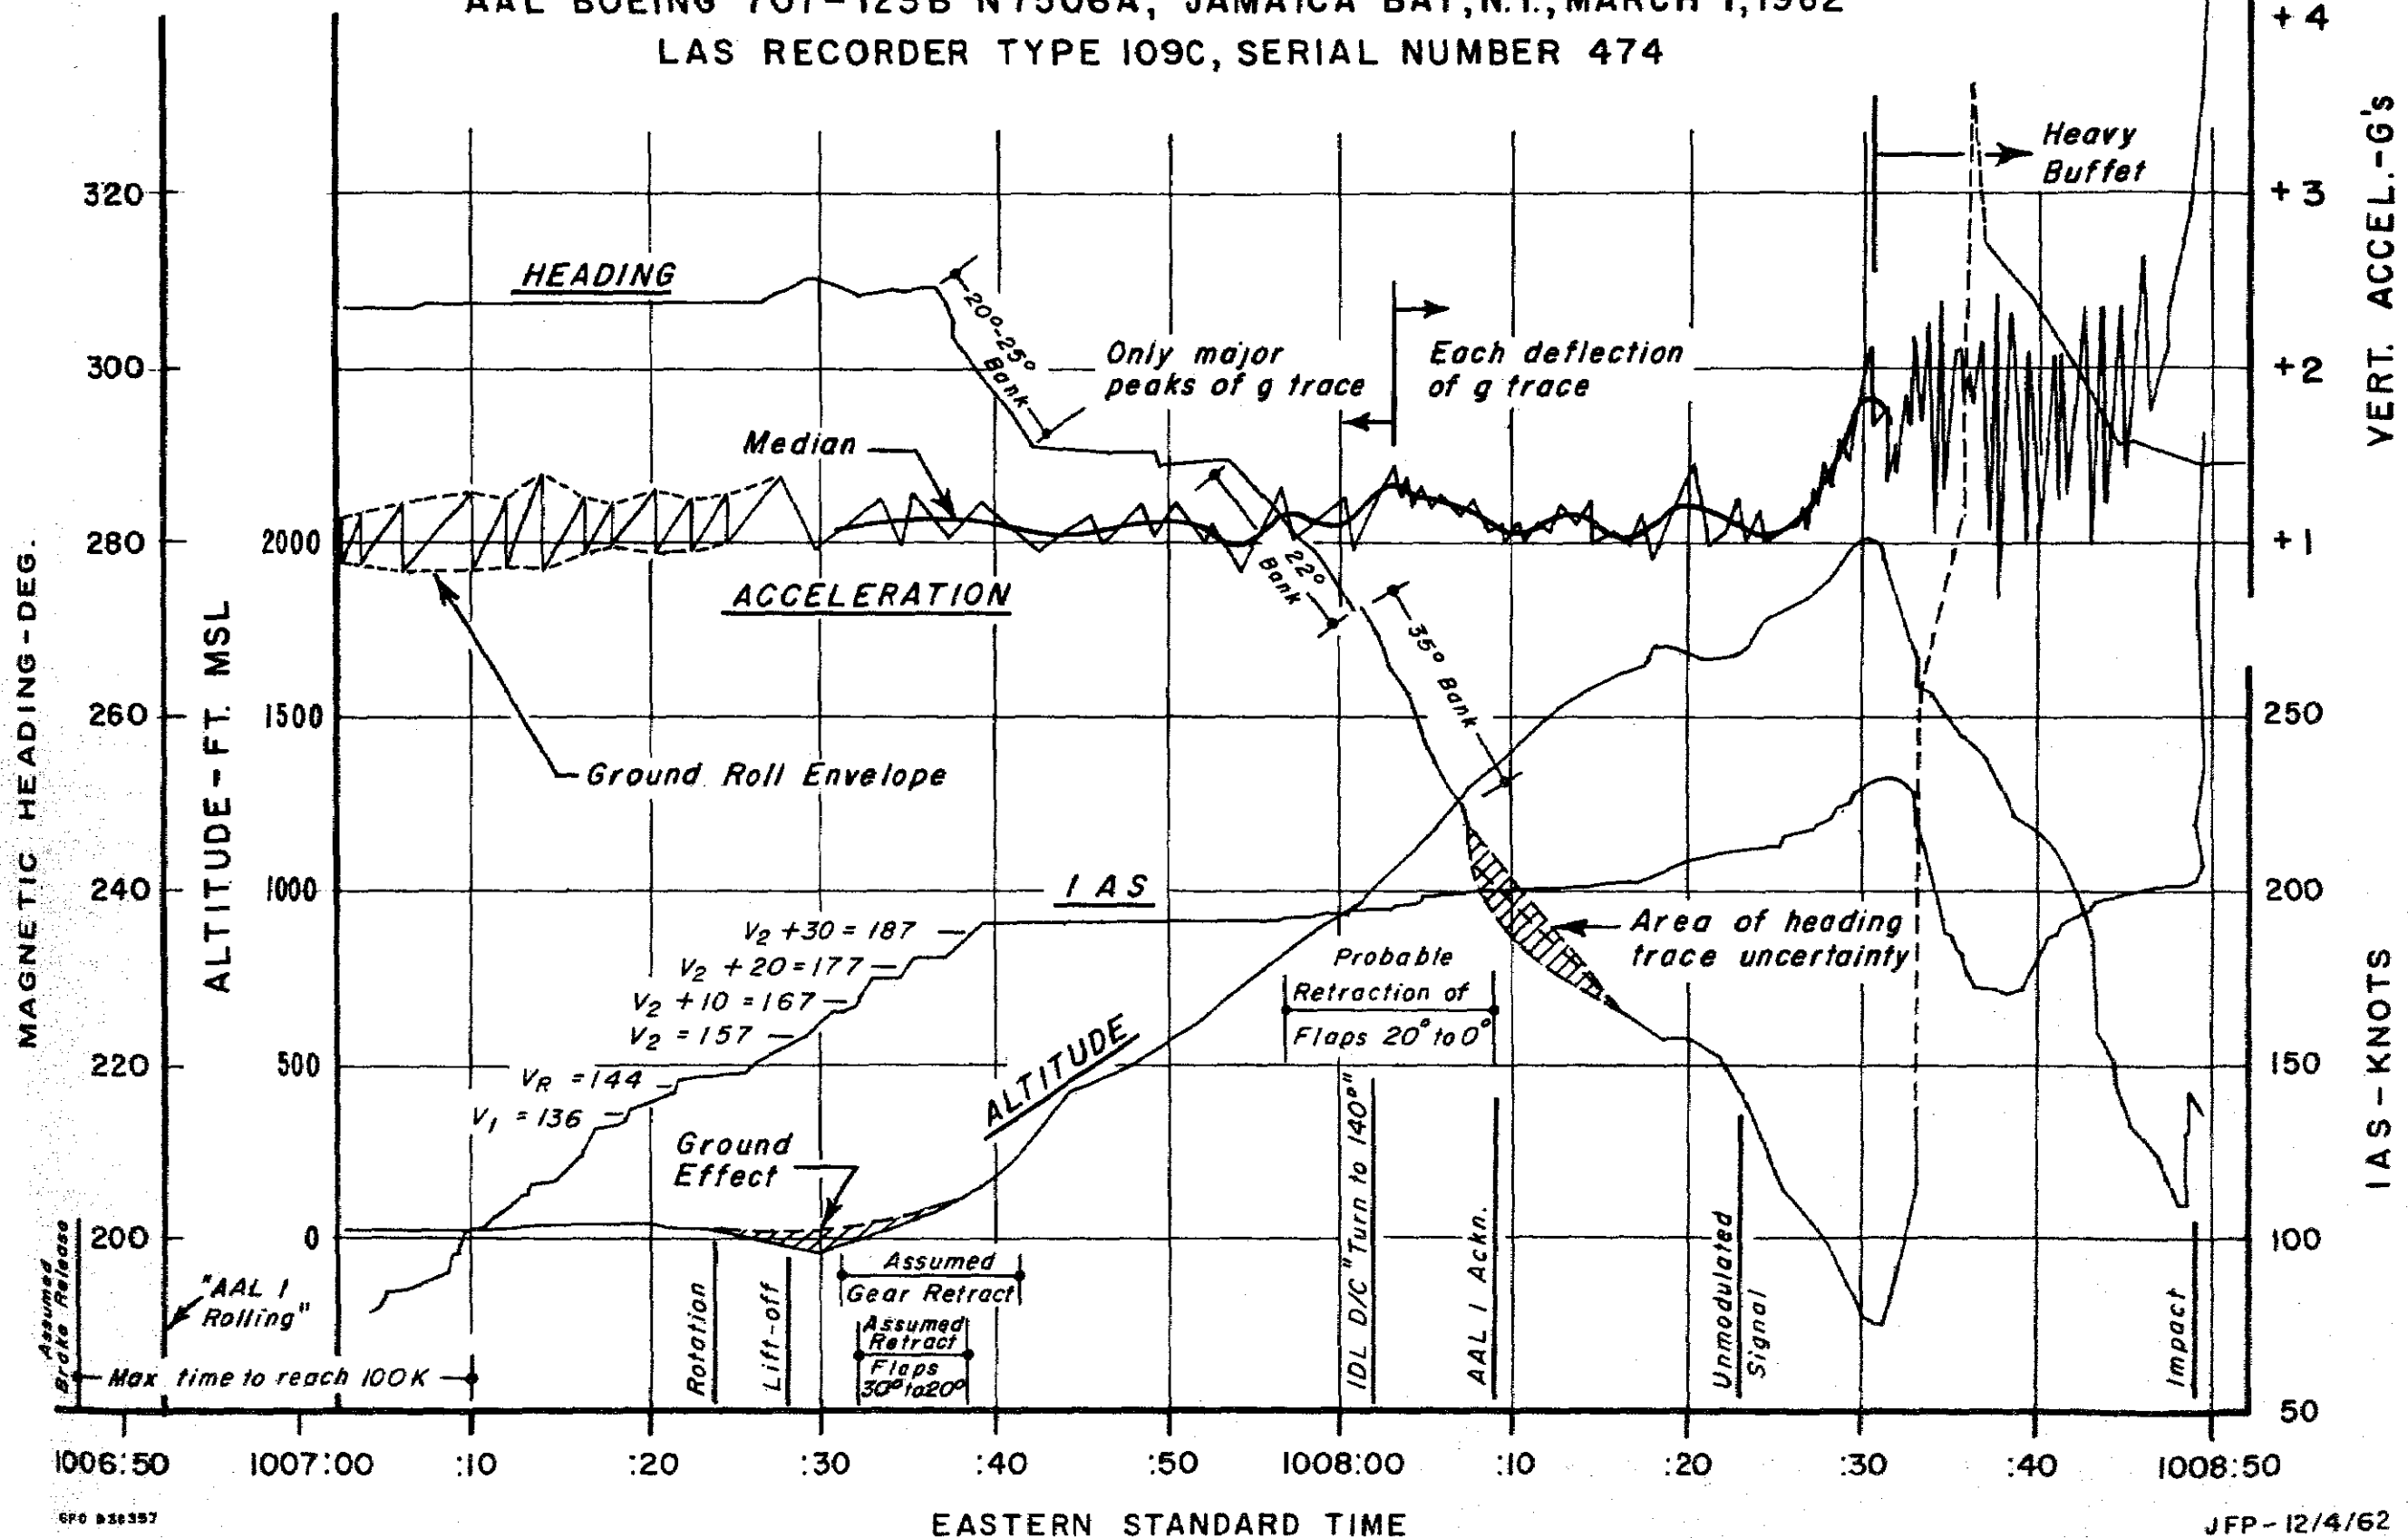
LAS RECORDER TYPE 109C, SERIAL NUMBER 474

Returning to time 1008:12, the beginning of the nose left yaw damper hard-over, it appears from the flight recorder traces that the airplane was in about a 30-degree bank. It follows then that an unopposed yaw damper hard-over would rapidly increase the bank angle to critical conditions. The first reaction of

The flight recorder traces suggest that at about 1008:33 the yaw damper was disengaged, accounting for the sharp decrease in indicated airspeed characteristic of a nose right slip. This leaves sufficient time for retarding the Nos. 1 and 2 throttles, with resultant reduction of the rpm to flight idle prior to impact. It appears likely that the rudder boost was deactivated shortly prior to impact, accounting for the 9 degree right rudder indication found in examination of the wreckage.
